# Manhole Inspection Summary

Manhole # S25MM\_027MH

Insp Date: **7/27/07 9:58 AM**

**Location** Address: **2401 LINDEN AVE**

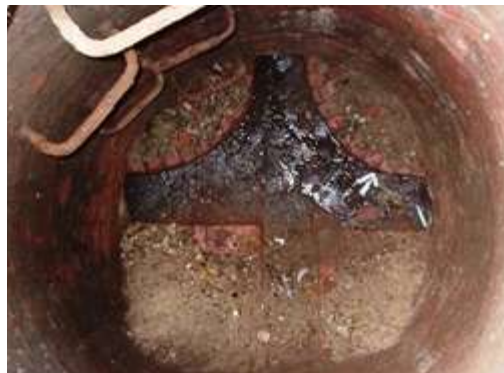
Top View

Corroded steps. Evidence of surcharge - Bench debris. Channel debris.

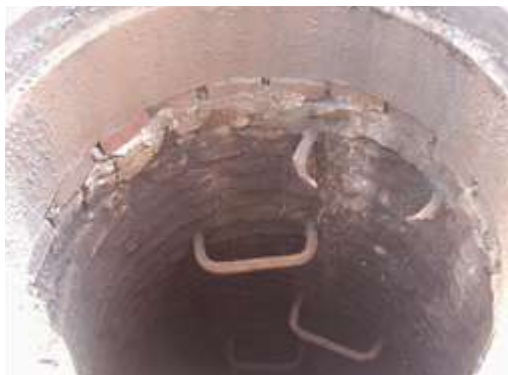
Defect

Frame leaks. Adjustment deterioration, loose brick and infiltration. Corbel infiltration. Missing steps.

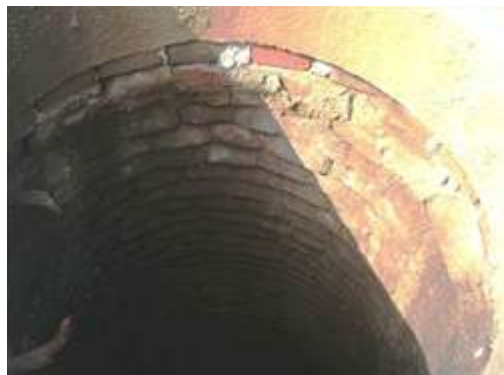
Defect

Frame leaks. Adjustment deterioration, loose brick and infiltration - other side.

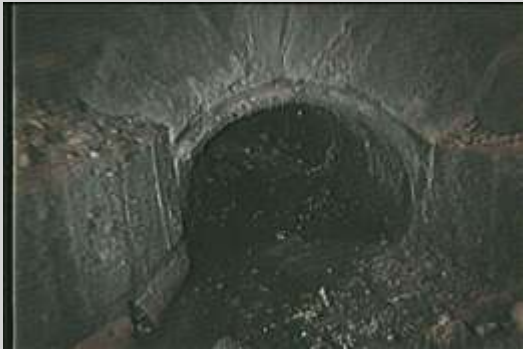
### 8 in. Circular Gravity Sewer Pipe Out @ 12 O'Clock

Deposits: ☐ None ☒ **Mud** ☐ Sludge ☒ **Debris** ☐ Grease

Silt Depth: **1** (in.) Deposits Extent: **Light**

Infiltration: **Evidence** Pipe Seal Cond: **Unknown**

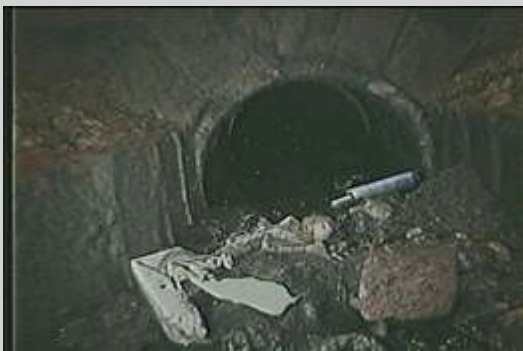
### 8 in. Circular Gravity Sewer Pipe In @ 3 O'Clock

Deposits: ☐ None ☒ **Mud** ☐ Sludge ☒ **Debris** ☐ Grease

Silt Depth: **3** (in.) Deposits Extent: **Medium**

Infiltration: **Evidence** Pipe Seal Cond: **Cracked**

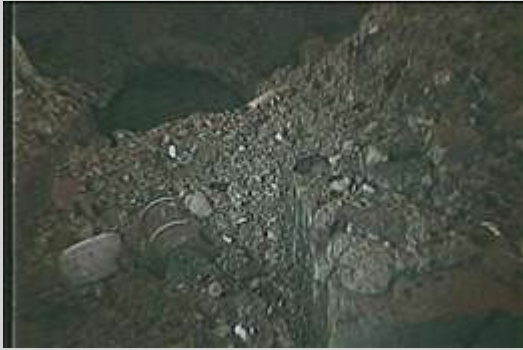
### Pipe In @ 6 O'Clock

Pipe Material: ☐ Pipe Lined  
Invert Depth: (ft.) Flow Characteristics: **None**  
Deposits: ☒ None ☐ **Mud** ☐ Sludge ☐ **Debris** ☐ Grease  
Silt Depth: (in.) Deposits Extent:  
Infiltration: **None** Pipe Seal Cond: **Cracked**

Connects To: **Stub connection / abandoned**

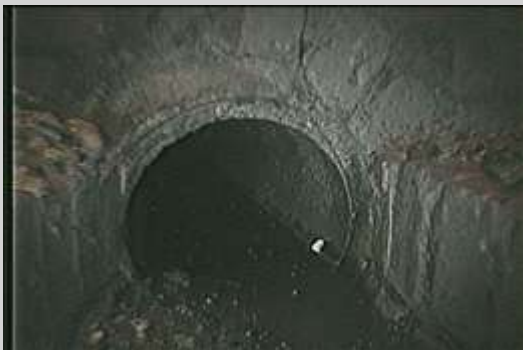
#### Pipe In @ 9 O'Clock

Rod and Bar (Angled)  
Pipe Material: **Clay** ☐ Pipe Lined  
Invert Depth: **11.70** (ft.) Flow Characteristics: **None**  
Deposits: ☐ None ☒ **Mud** ☐ Sludge ☒ **Debris** ☐ Grease  
Silt Depth: **1** (in.) Deposits Extent: **Light**  
Infiltration: **Evidence** Pipe Seal Cond: **Unknown**
